# Town of Marlboro Local Hazard Mitigation Plan

Draft April 7, 2016

Prepared for the Town of Marlboro  
By the  
Windham Regional Commission

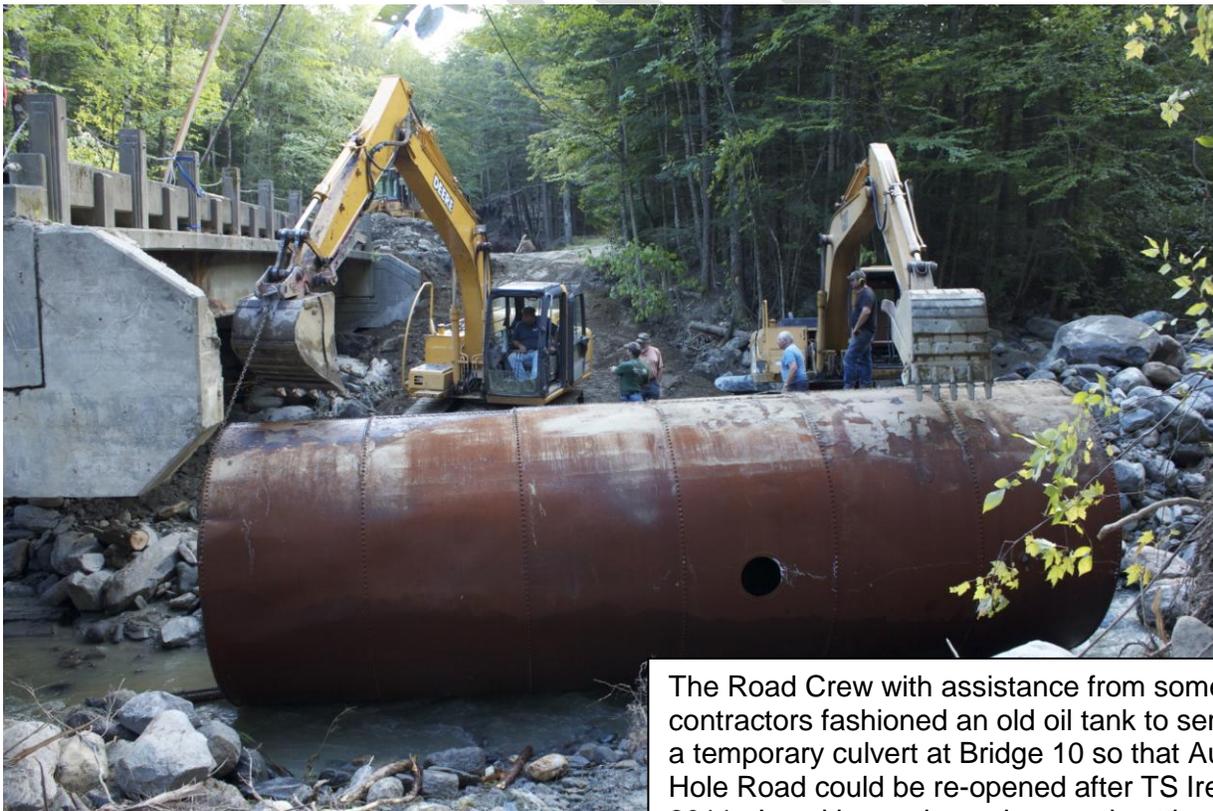
The Road Crew with assistance from some local contractors fashioned an old oil tank to serve as a temporary culvert at Bridge 10 so that Augur Hole Road could be re-opened after TS Irene in 2011. Local ingenuity and a can-do attitude helped Marlboro recover after the devastation. Photo courtesy of Forrest Holzapfel

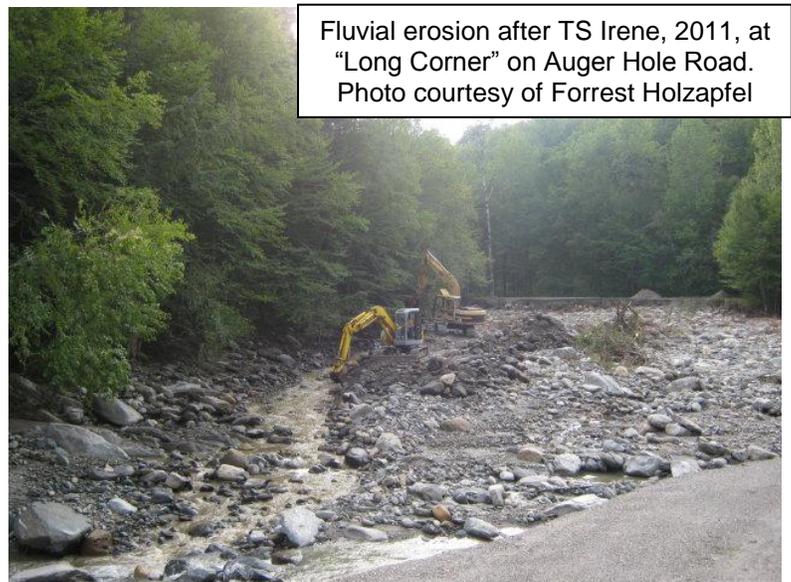
Fluvial erosion after TS Irene, 2011, at "Long Corner" on Auger Hole Road. Photo courtesy of Forrest Holzapfel

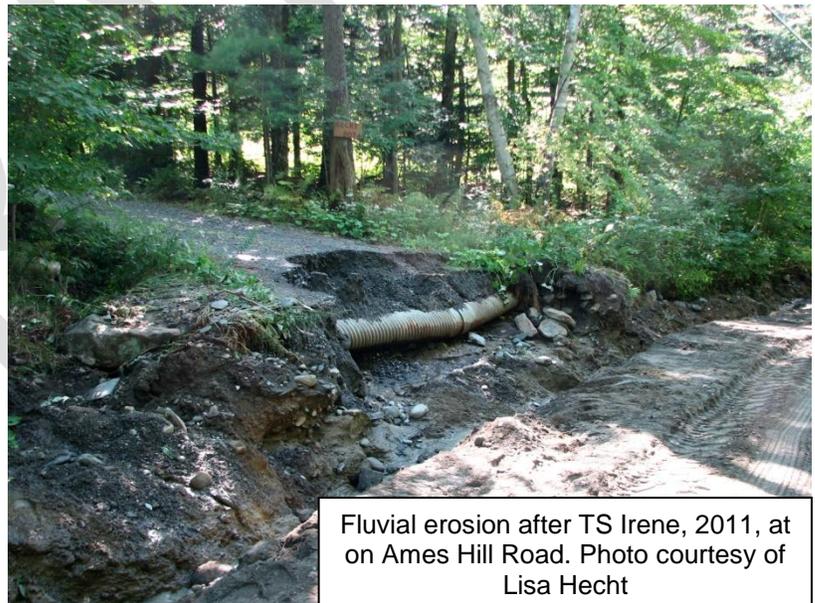
Fluvial erosion after TS Irene, 2011, at Ames Hill Road. Photo courtesy of Lisa Hecht

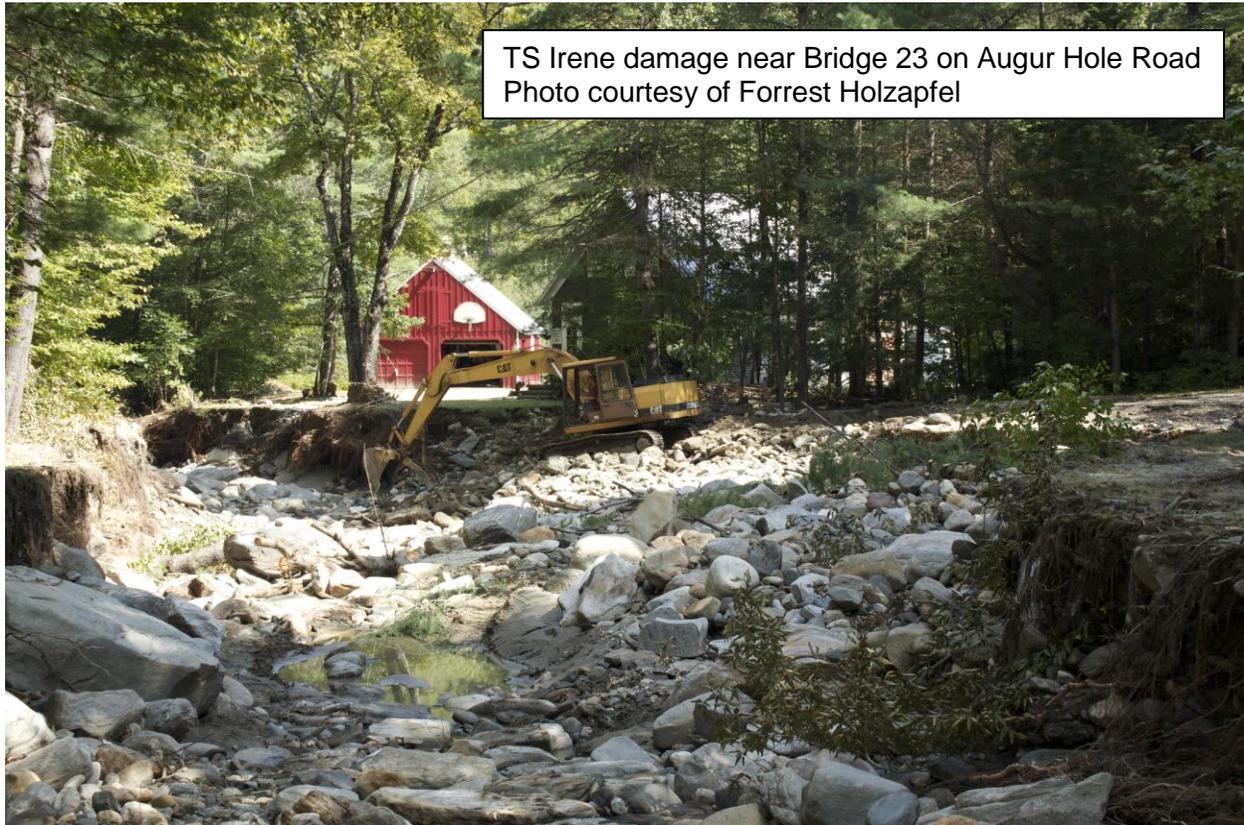
TS Irene damage near Bridge 23 on Augur Hole Road  
Photo courtesy of Forrest Holzapfel

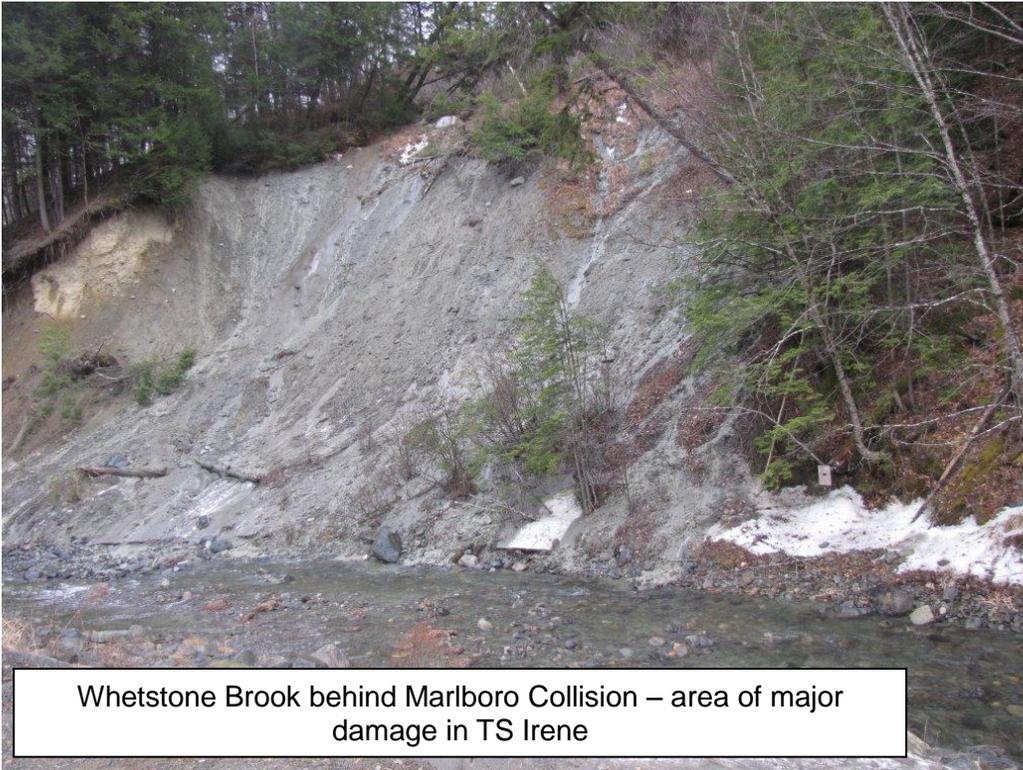
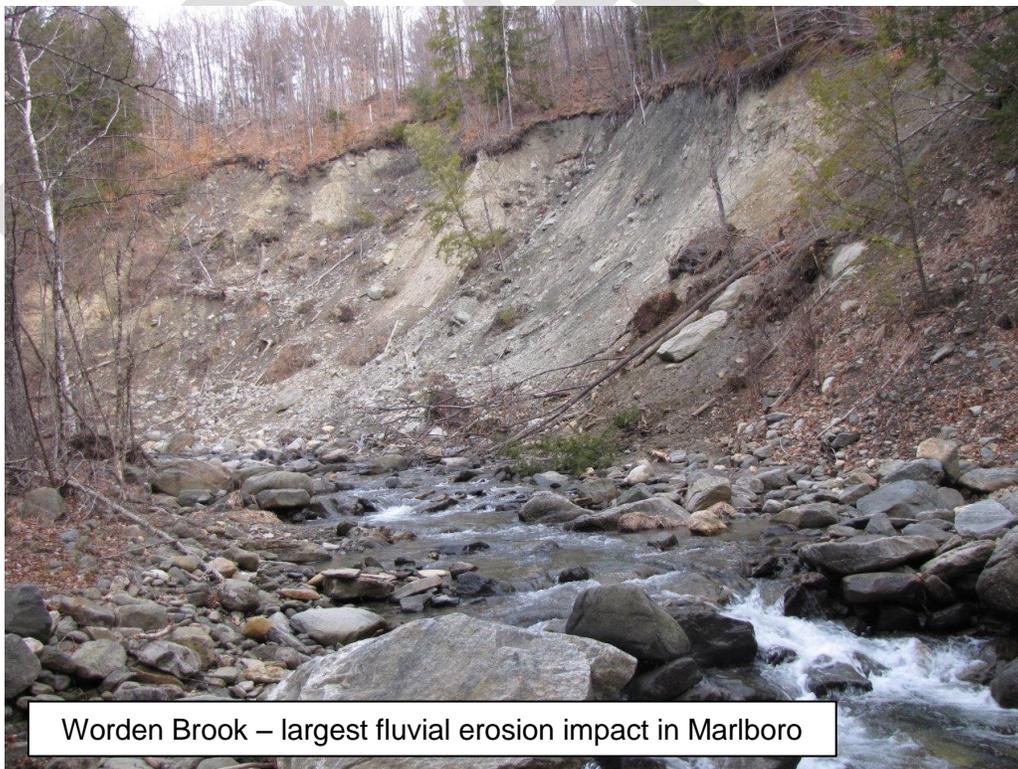
12. Fluvial Erosion Images taken March 2016 (courtesy of Road Foreman David Elliot)

Worden Brook – largest fluvial erosion impact in Marlboro

Bridge 10 is on the bottom of the area of this event, and there has been some shoring up around that bridge. Debris from Worden Brook washed down and plugged the bridge, which didn't take the bridge out, but took the land out all around it. The bridge was not upgraded in the repair. The riprap was put back and the channel was put back in place. This bridge could potentially be a hazard again, though much of the debris came down with TS Irene, though more debris is created all the time and fluvial erosion Worden Brook remains an issue.

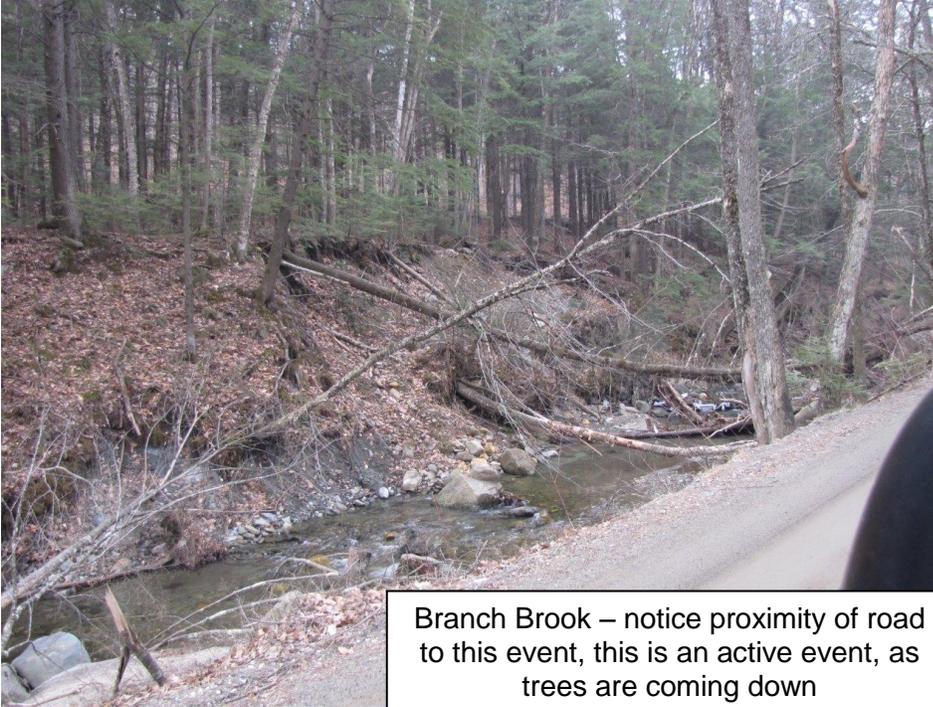
Branch Brook – notice proximity of road to this event, this is an active event, as trees are coming down
